CCDC Parking Garage Pedestrian Safety Review

Final Report

September 2015

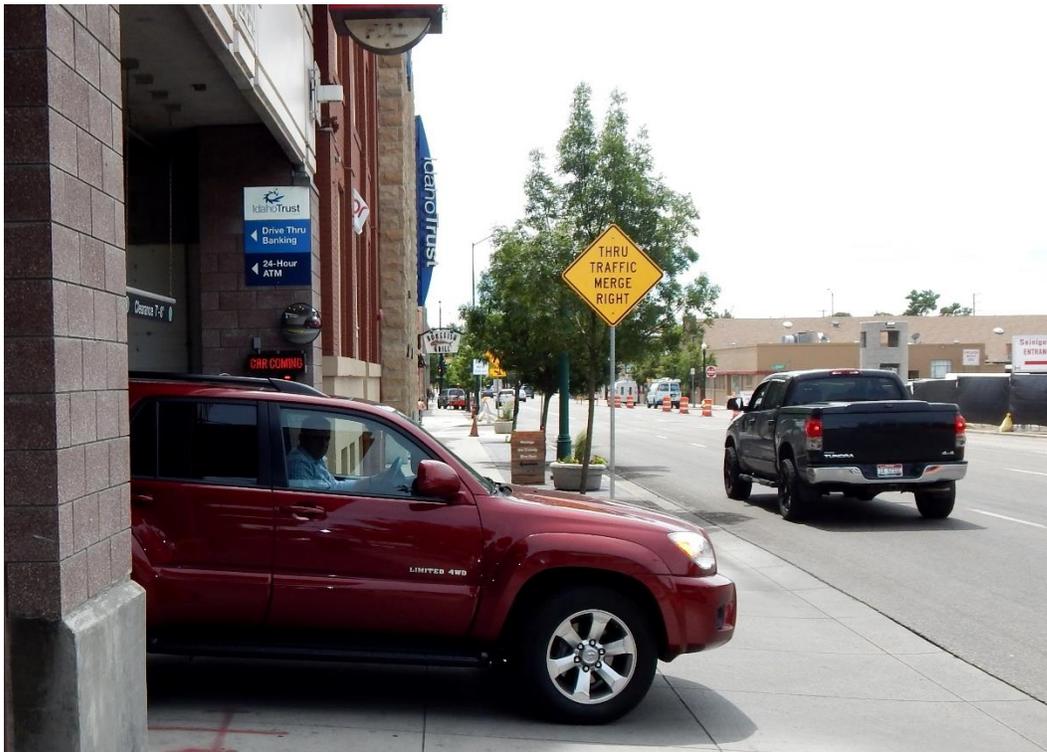
In all cases, in lanes that had the electronic “Caution Car Coming” signs and audible devices, these devices were functioning.

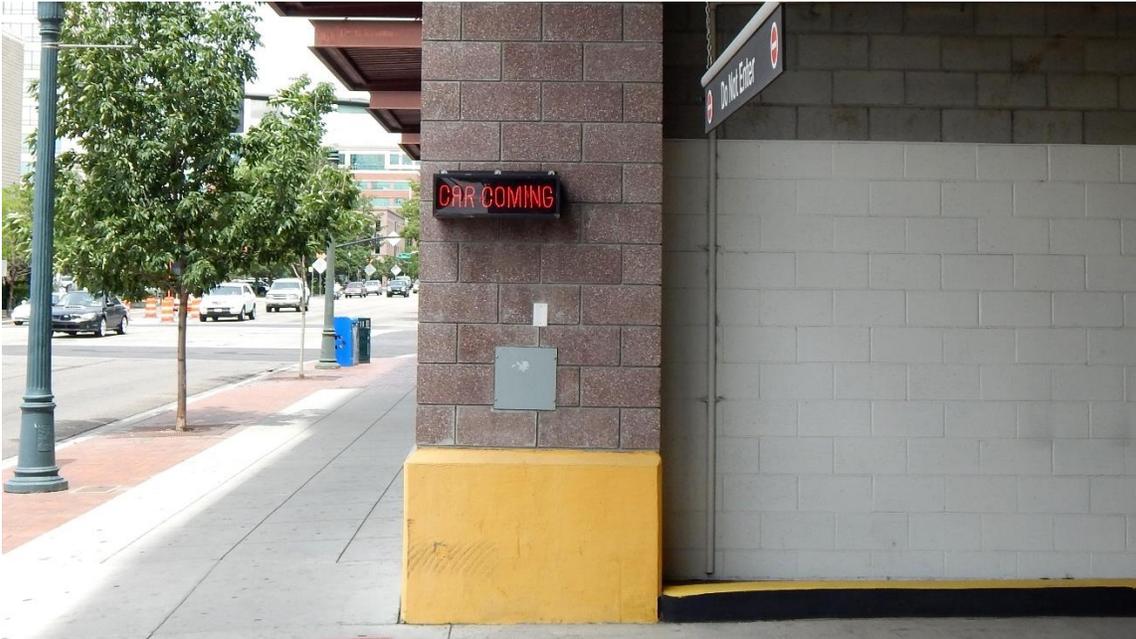
It was noted that while most of the other CCDC garages, with the exception of the Grove Street garage, had most of the same basic equipment installed (convex mirrors, “caution car coming” neon signs, laser sign/alarm activation system, horn/audible warning devices, laser sign/alarm activation system, etc.) the City Centre garage did not have audible warning devices/audio alarm activation system installed. For consistency purposes, it is recommended that the audible warning devices/audio alarm activation system be installed in the City Centre garage.

- Add audible alarm feature to the exit lanes of the City Centre garage to make the package of pedestrian safety devices consistent among all CCDC garages.

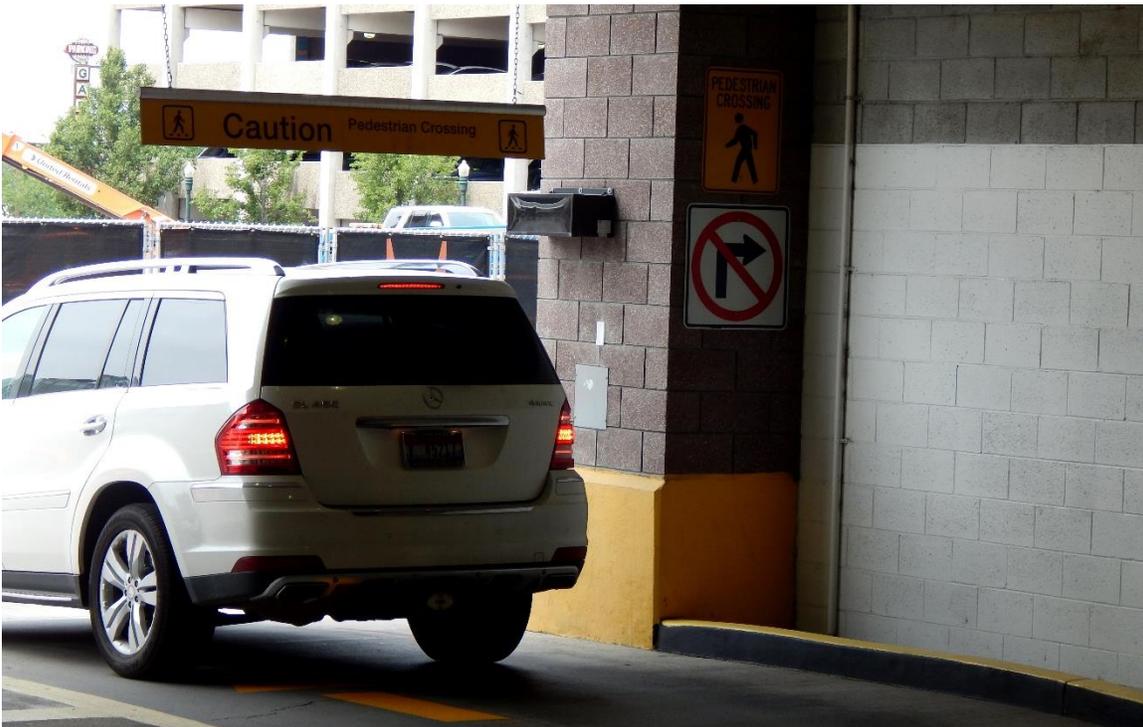
One other potential issue was noted in the City Centre garage. In one instance, an exiting car pulled forward then stopped momentarily before proceeding out the exit. In this case, the electronic sign, which had been operating, stopped after the designated period of time. However, in this case, since the car had stopped briefly and there is distance of approximately 60' from the exit gate to the sidewalk, the warning signage was not active once the car reached the sidewalk. See photo below. It is recommended that the system be programmed to activate

the signage (and the recommend audio alarm) for a slightly longer period of time.

2. Another minor concern, as noted on pages 8 -10, is the issue related to the duration of the activation of the pedestrian warning devices and the installation of the audible alarm mechanism in the City Center garage. It is recommended that the exit signage/recommended audible alarm activation mechanism be evaluated to see if it is possible to extend the alarm period via system programming. It is recommended that

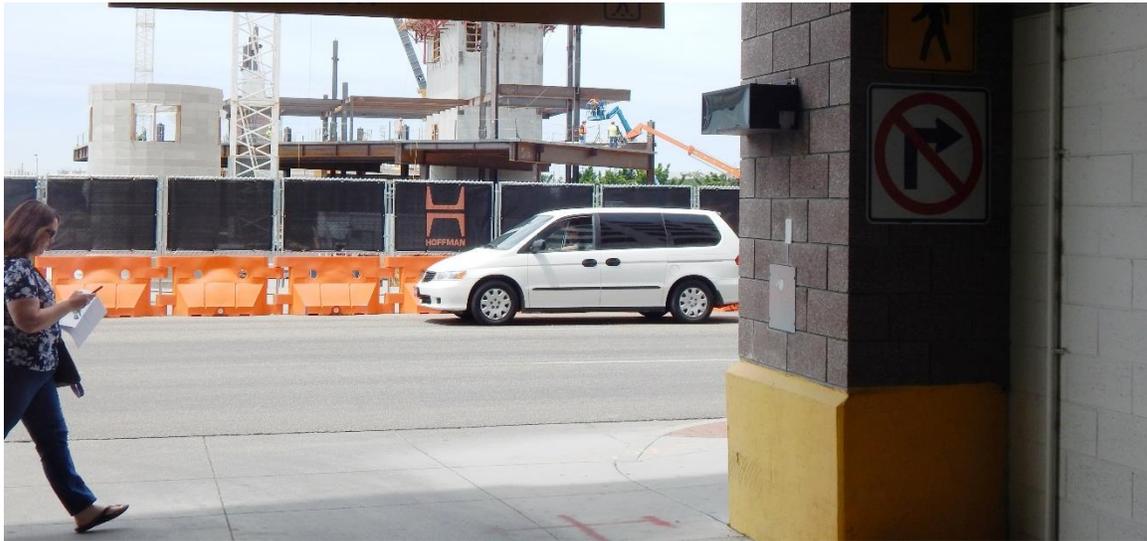
The photo below illustrates the degree of distraction that modern technology adds to an already potentially hazardous condition (note the “distracted pedestrian” reading her cell phone while walking in front of a garage exit lane).

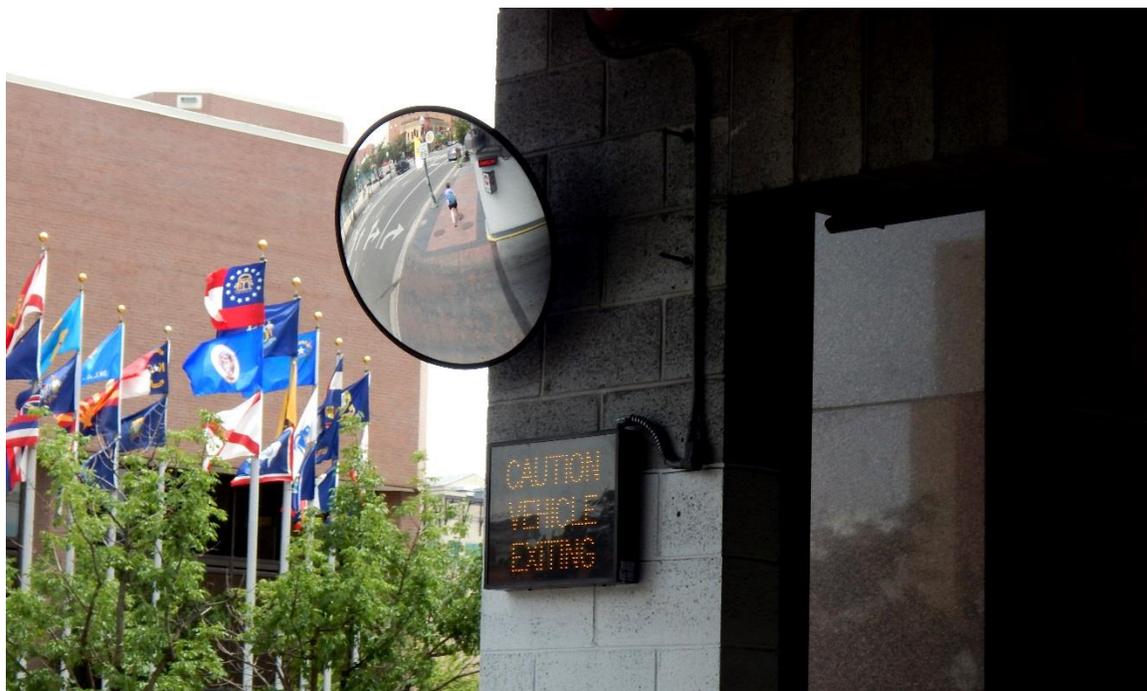
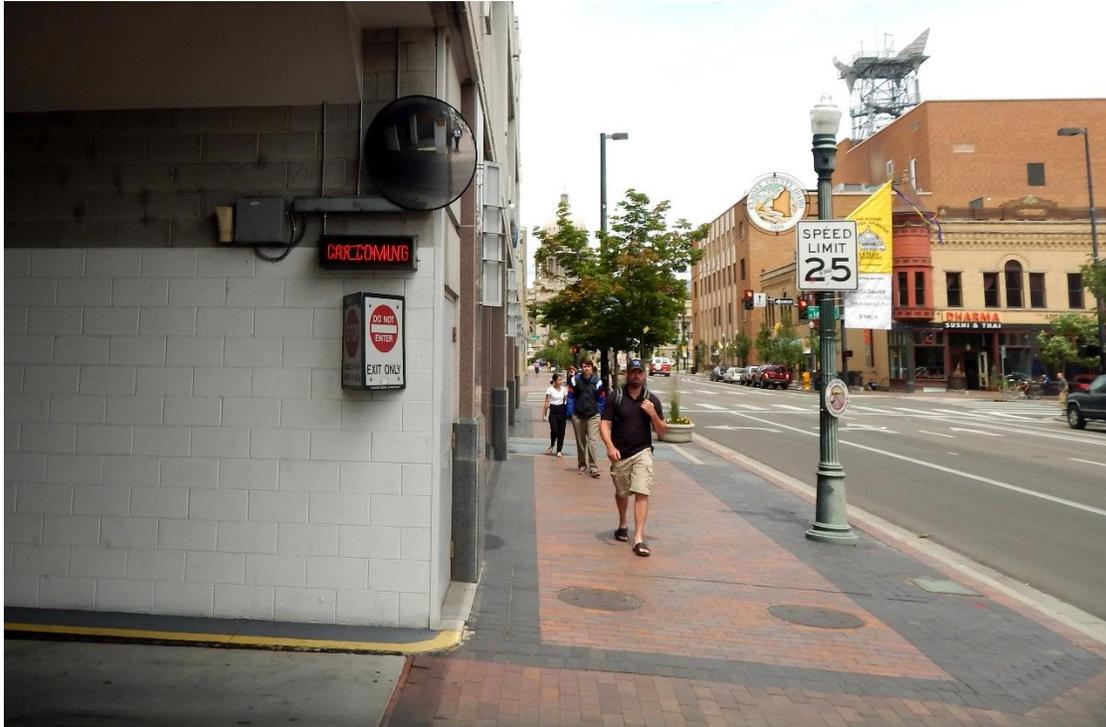
All the convex mirrors were clean, unbroken and properly positioned.

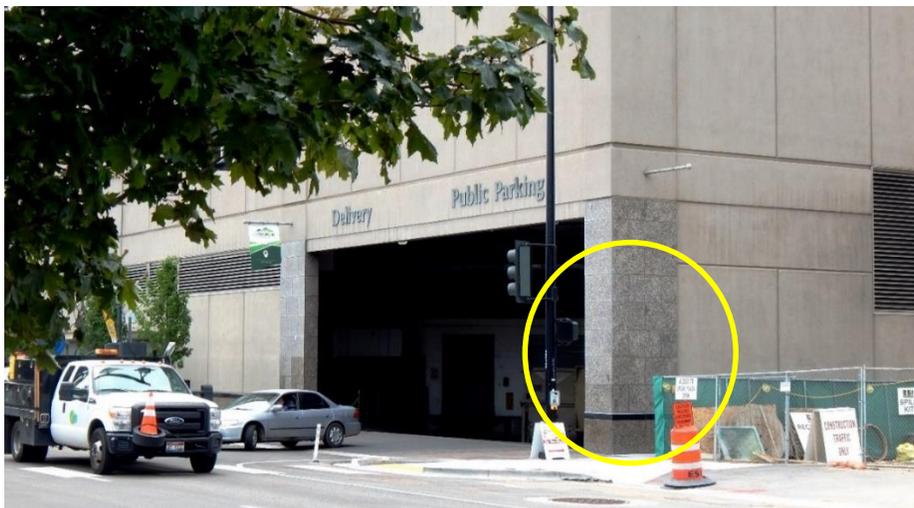
One other concern noted was that the “Caution Car Coming” signage at the Boulevard garage is not positioned to be useful to pedestrians walking South on Capitol Boulevard (see photo below).

As noted on page 11 of this report, an additional “Caution Car Coming” is recommended at the exit to the Boulevard Garage oriented to pedestrians walking south on Capitol Blvd.

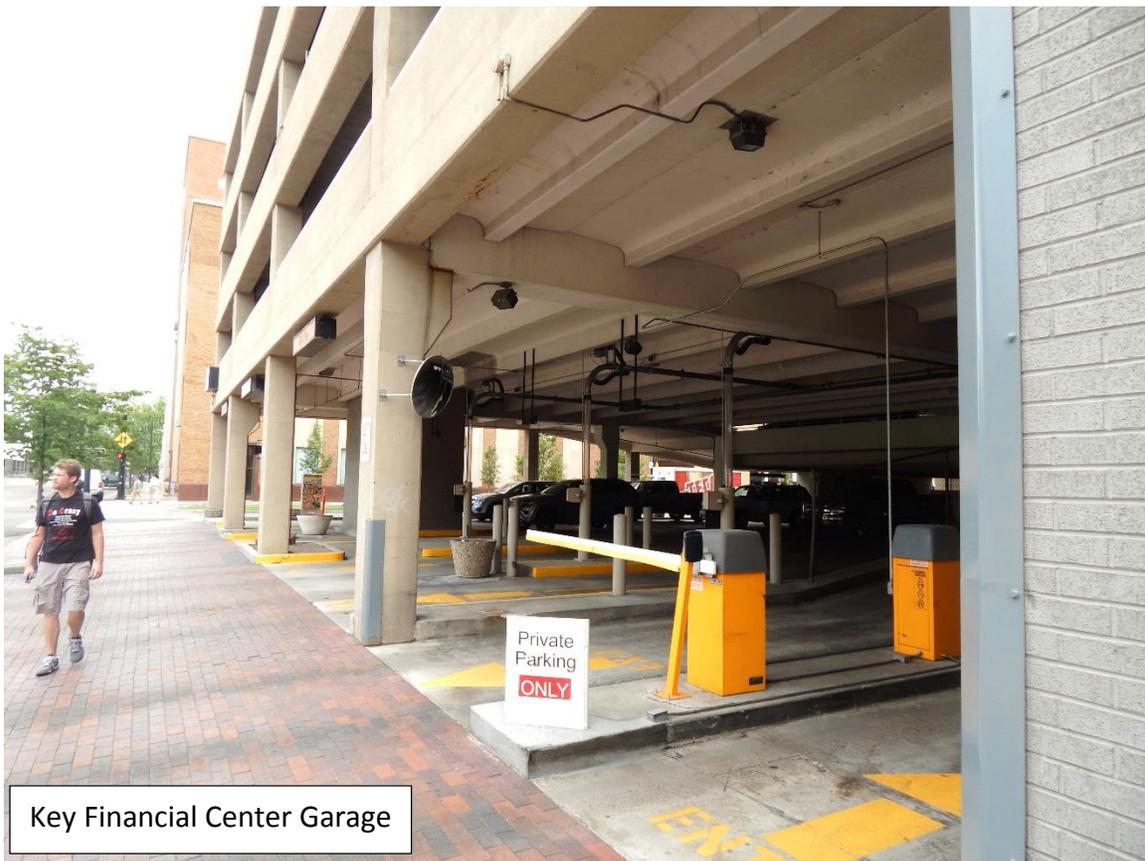
For the most part, the non-CCDC garages had less pedestrian safety features than those facilities operated by CCDC. None had the “Caution Car Coming” signage, audible alarms or other pedestrian warning signage. A limited use of convex mirrors was noted in some garages. Examples of current conditions in these other garages are illustrated in the following photos.

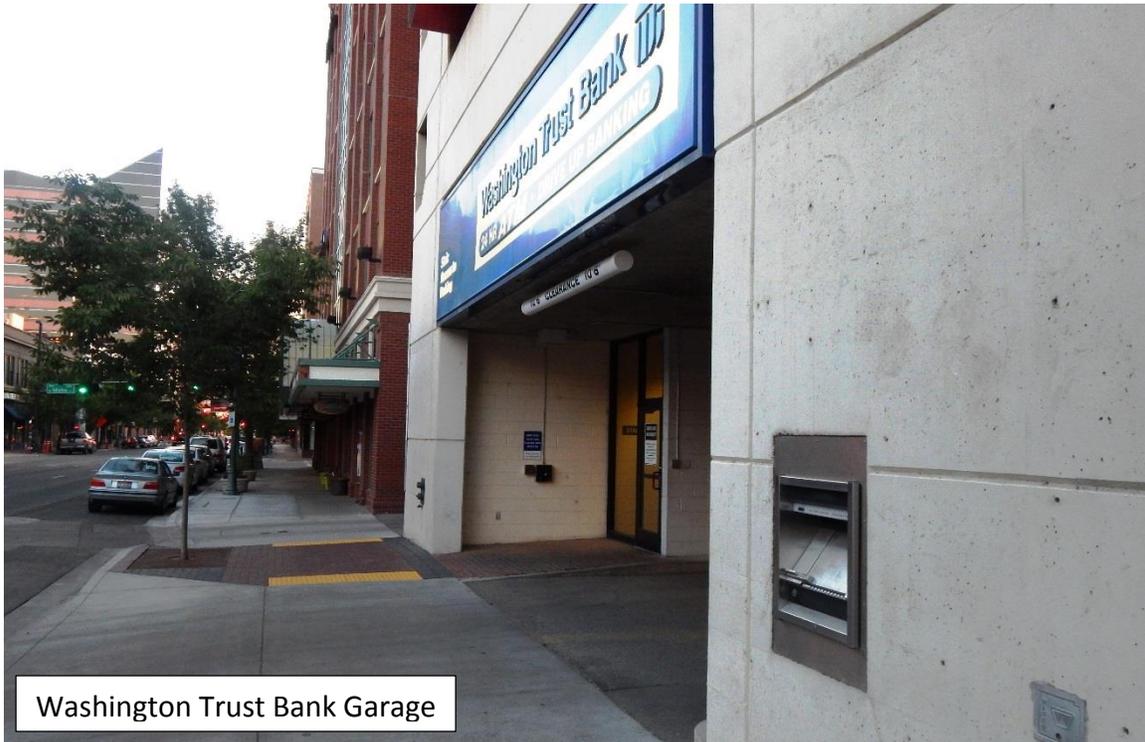
Washington Trust Bank Garage

The one element that the Washington Trust Bank garage had that no other garage had in place was the use of what are known as “truncated domes” as a pedestrian warning device on the sidewalks in advance of the garage exit lanes.

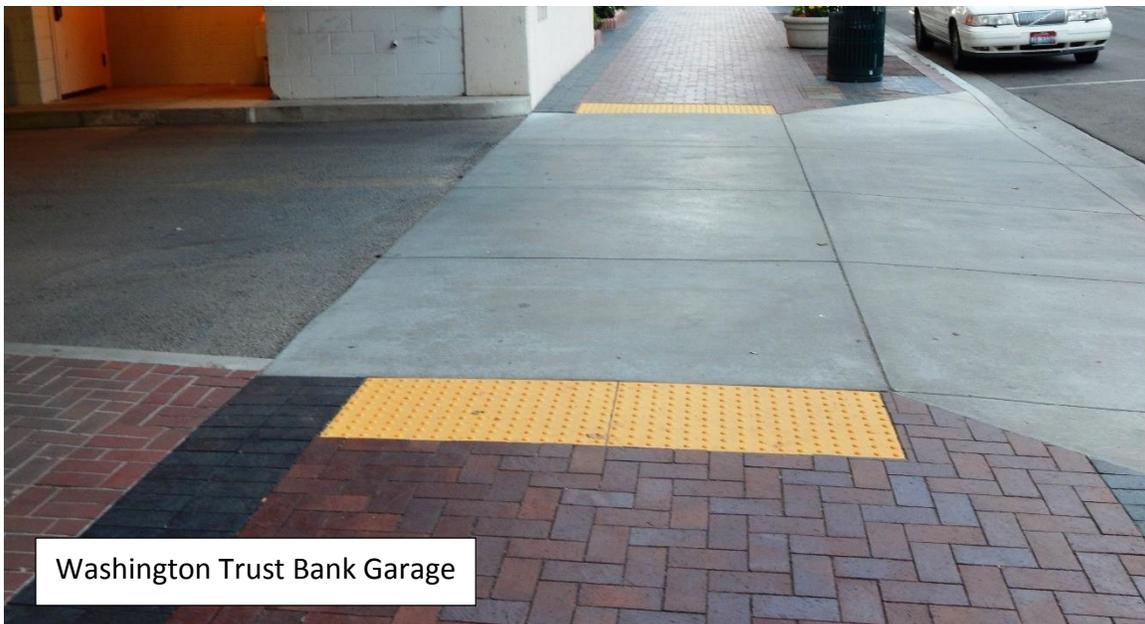
Washington Trust Bank Garage

A close-up of this feature is provided in the photo below.

4. The practice of adding “truncated domes” in the sidewalks on either side of garage exit lanes (or some other change in pattern, color or texture) should be considered as a potential new element to the CCDC pedestrian safety standard.

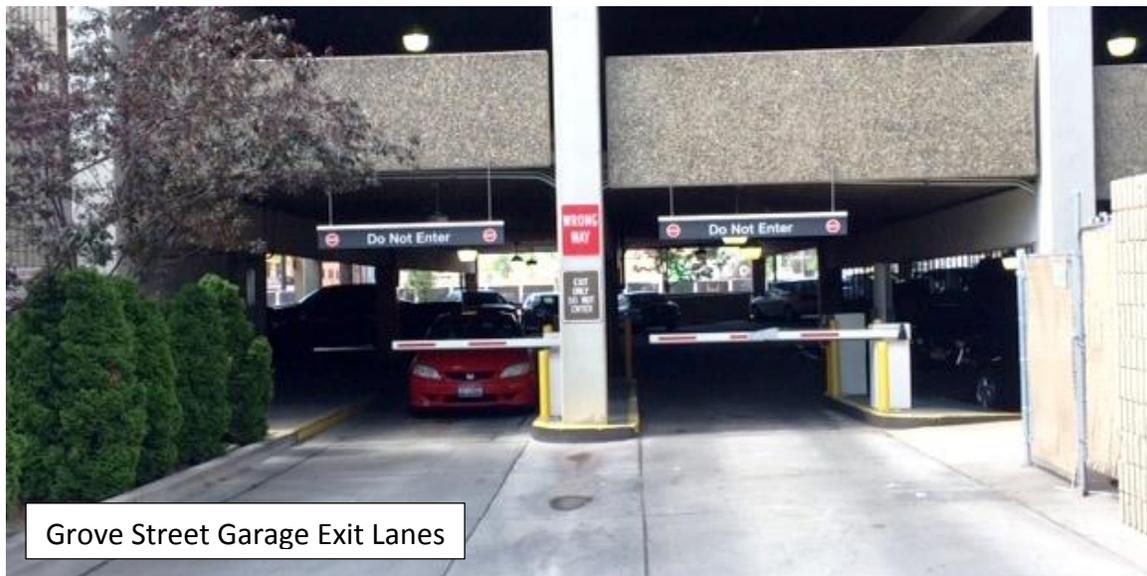
Grove Street Garage Exit Lanes

1. If there is any concern to be noted regarding the CCDC system it would be a slight lack of overall consistency. For example, the exit lanes from the Grove Street garage do not have the same treatment as the other CCDC garages in terms of use of electronic signage, audible alarms or sign/alarm activation systems.

While the exit lanes from this garage do not cross a major pedestrian route, there is a minor pedestrian route near an elevator tower that creates enough pedestrian traffic to raise a concern.

- Upgrade the exit from the Boulevard garage and the two Grove Street garage exit lanes by adding:

- Electronic “Caution Car Coming “ signs
- Audible alarms
- Sign/alarm activation system
